GOLF VILLAGE FORCE MAIN  
OUTFALL AND DOWNSTREAM  
SEWER IMPROVEMENTS  
PROJECT

### **Level 1 MACP Inspection Forms**

### **Site Access Photo Log**

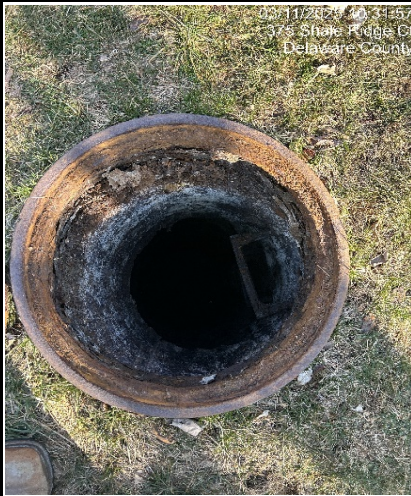
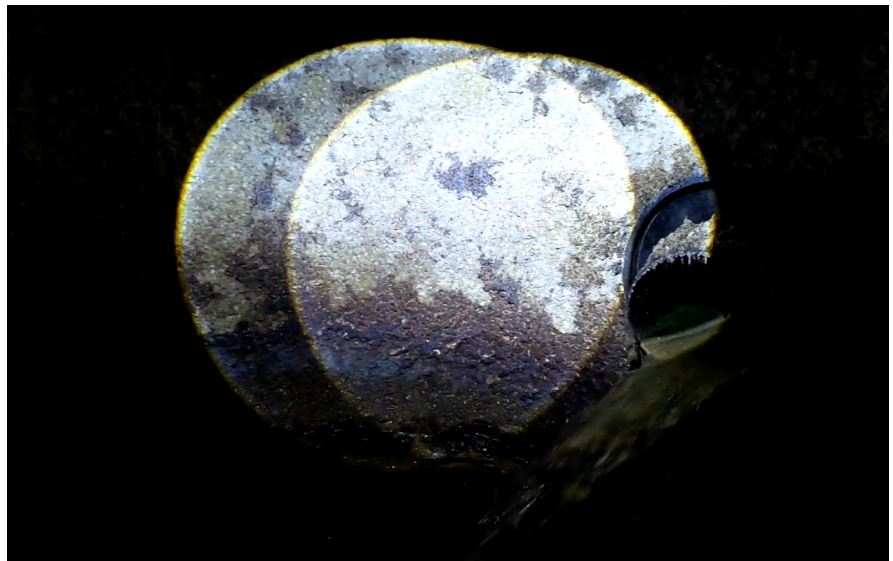
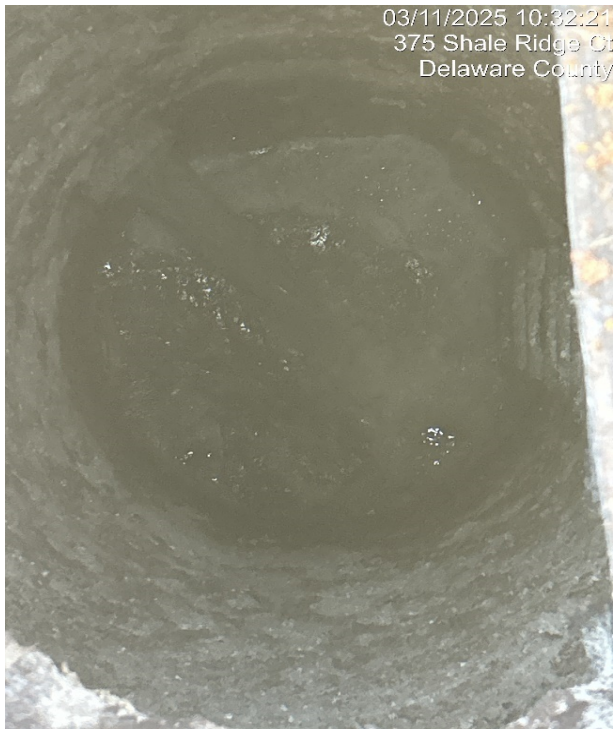
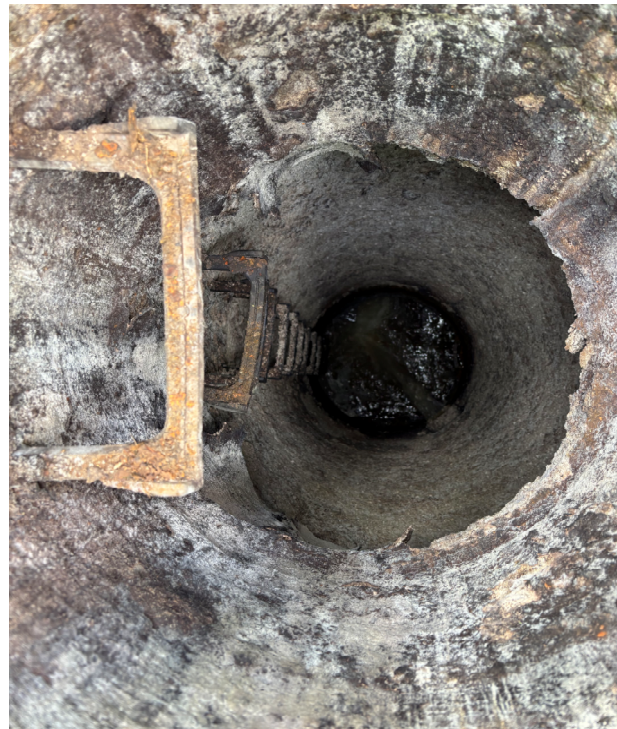
| 21. DRAINAGE AREA | 22. MH/ACCESS POINT NO, (1,2)<br>09MH001353000001 | 23. STREET (1,2)<br>Shale Ridge Ct | 24. CITY (1,2)<br>Powell, OH |

D = DEFECTIVE (AGGREGATE EXPOSED AND ERODING)

| 86. LINING EXTERIOR | 87. CONE CONDITION (1)<br>D = DEFECTIVE (AGGREGATE EXPOSED AND ERODING) | | |

| 92. WALL LINING INTERIOR | 93. WALL LINING EXTERIOR | 94. WALL CONDITION (1)<br>D = DEFECTIVE (AGGREGATE EXPOSED AND ERODING) |

SURCHARGED MATERIAL (PAPER) DEPOSITED UP TO FRAME & LID.

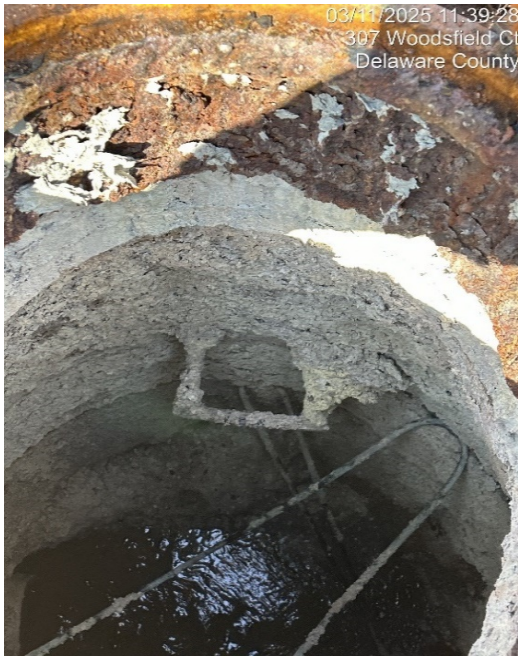
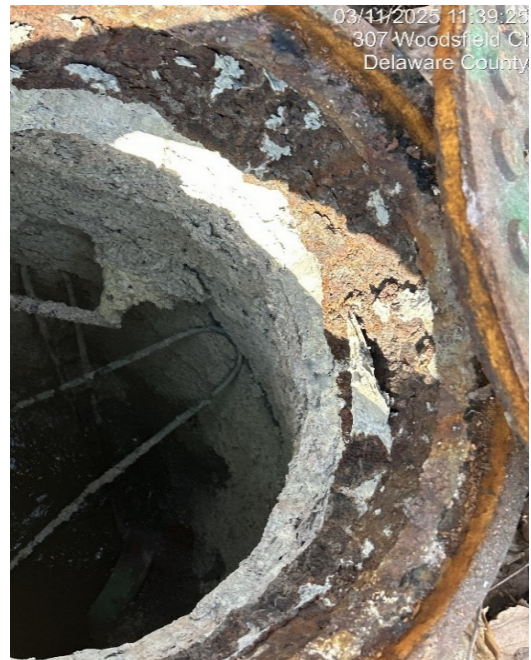
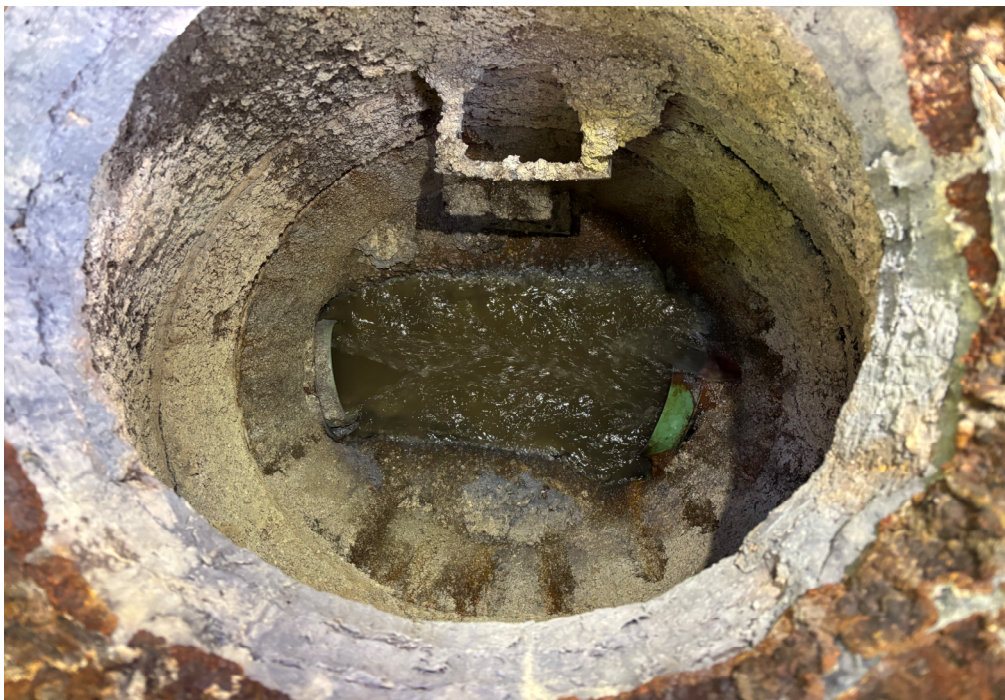
| 21. DRAINAGE AREA | 22. MH/ACCESS POINT NO, (1,2)<br>09MH001353000002 | 23. STREET (1,2)<br>Woodsfield Ct | 24. CITY (1,2)<br>Powell, OH |

D = DEFECTIVE (APPEARS AGGREGATE EXPOSED)

| 86. LINING EXTERIOR | 87. CONE CONDITION (1)<br>D = DEFECTIVE (APPEARS AGGREGATE EXPOSED) | | |

| 92. WALL LINING INTERIOR | 93. WALL LINING EXTERIOR | 94. WALL CONDITION (1)<br>D = DEFECTIVE (APPEARS AGGREGATE EXPOSED) |

MATERIAL & PAPER DEPOSITS EXTEND TO FRAME & CASTING. INFILTRATION GUSHER AND RUNNER AT BOOT SEALS.

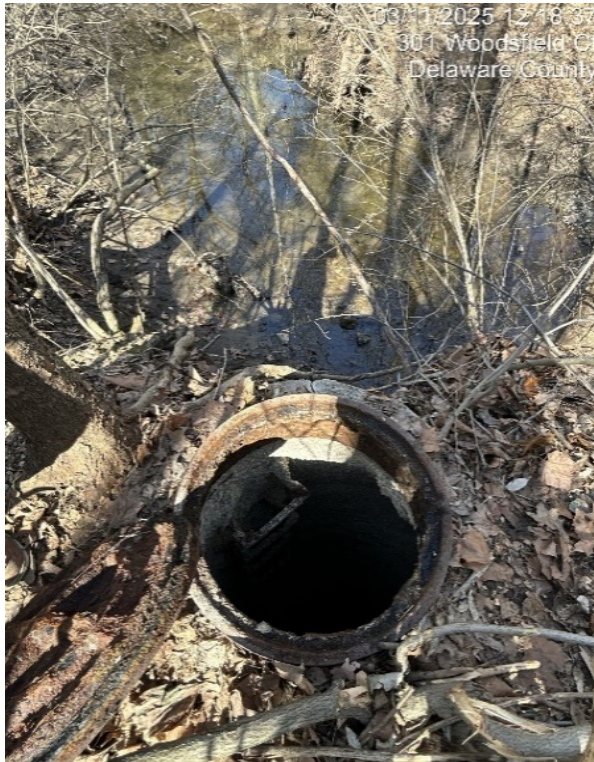
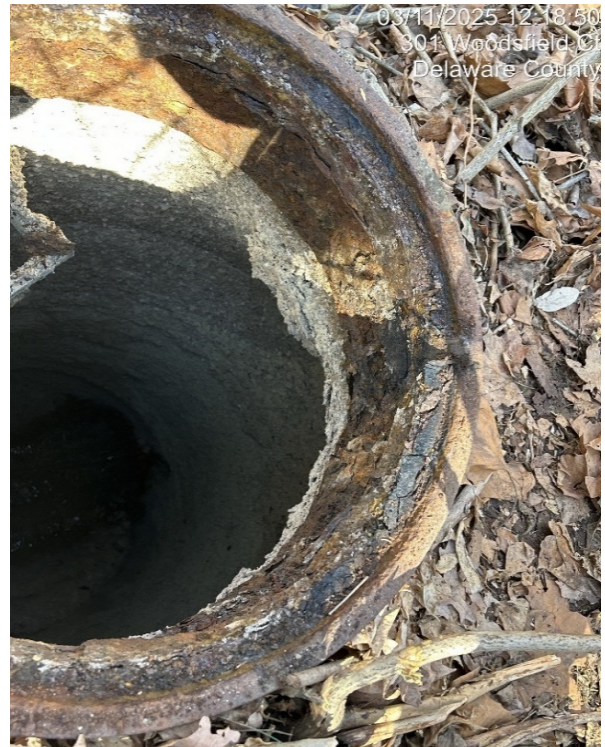
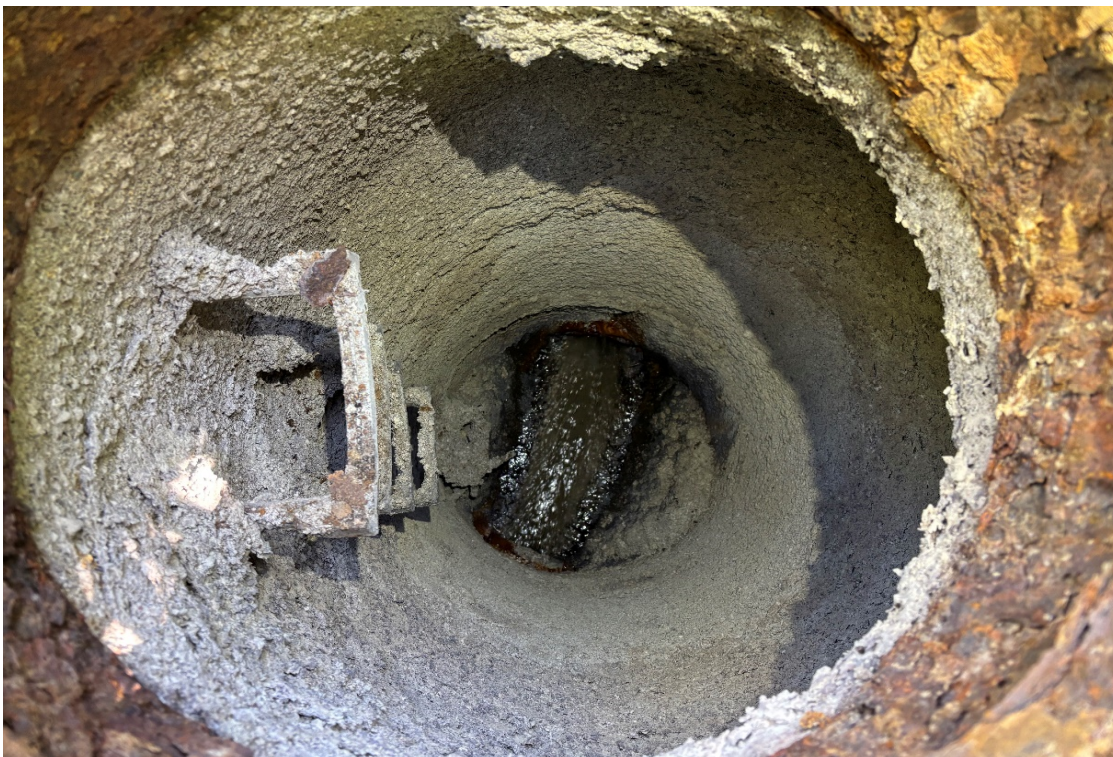
| 21. DRAINAGE AREA | 22. MH/ACCESS POINT NO, (1,2)<br>09MH001353000003 | 23. STREET (1,2)<br>Woodsfield Ct | 24. CITY (1,2)<br>Powell, OH |

| 81. CHIMNEY CONDITION (1)<br>D = DEFECTIVE (APPEARS AGGREGATE EXPOSED) | | | |

| 86. LINING EXTERIOR | 87. CONE CONDITION (1)<br>D = DEFECTIVE (APPEARS AGGREGATE EXPOSED) | | |

| 92. WALL LINING INTERIOR | 93. WALL LINING EXTERIOR | 94. WALL CONDITION (1)<br>D = DEFECTIVE (APPEARS AGGREGATE EXPOSED) |

MATERIAL & PAPER DEPOSITS EXTEND TO FRAME & CASTING.

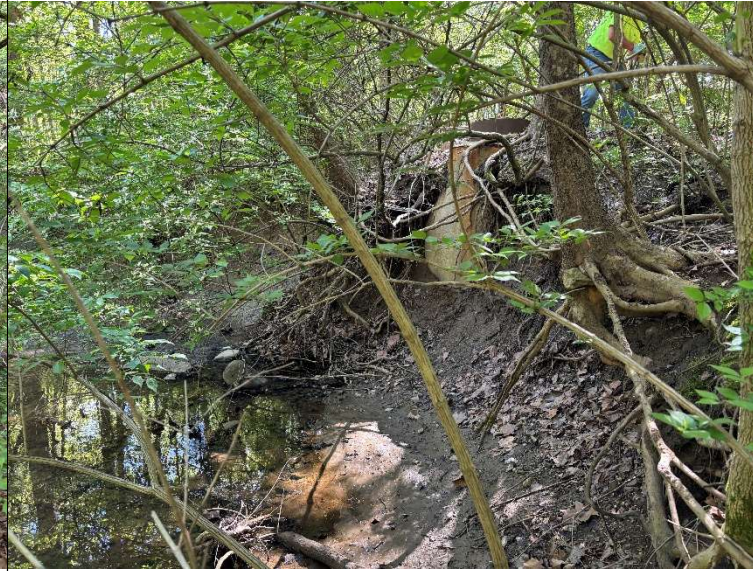
Picture 22: 22 - Stream Erosion at Manhole 03

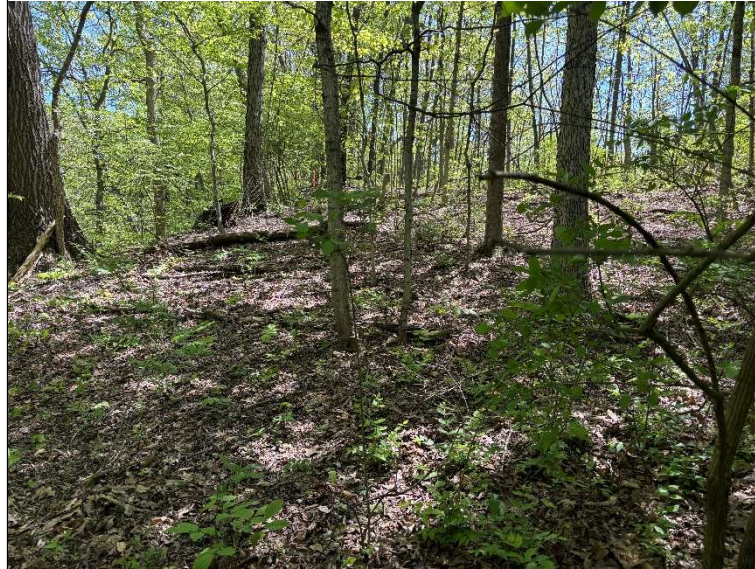
Picture 28: 28 - Cliff Edge Near MH 12

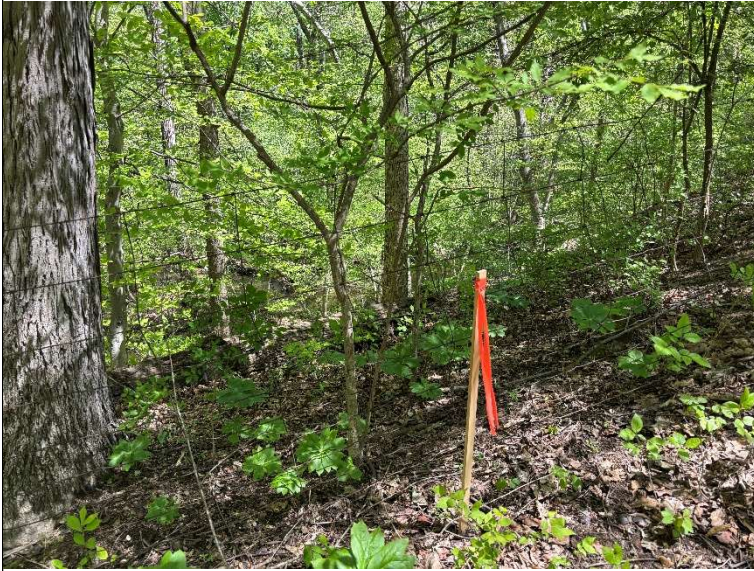
Picture 29: 29 - Cliff Edge Overlook Stream Near MH 12
