**FINAL REPORT  
OF  
PHASE 1 – PRELIMINARY ENGINEERING SERVICES**  
*Golf Village Force Main Outfall and Downstream Sewer Improvements*

*PO No. P2502198*

*Liberty Township, Delaware County, Ohio*

June 30, 2025

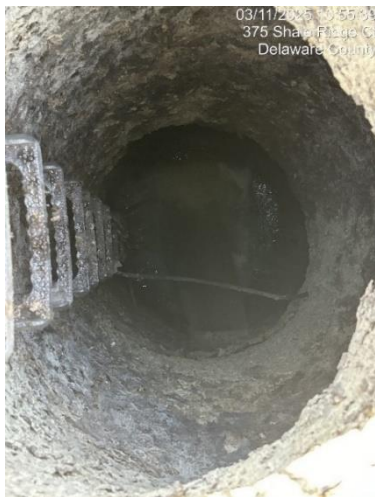
MH #	Depth (ft)	Evidence of Surge?	Overall Condition					Notes
			Cover	Frame	Chimney	Cone	Wall	
MH 13	18.6	Yes	Corroded (Pitted)	Corroded (Pitted/Worn)	N/A	Defective	Defective	Poor Condition - Aggregate Exposed and Eroding
MH 01	18.3	Yes	Corroded (Pitted)	Corroded (Pitted/Worn)	Defective	Defective	Defective	Poor Condition - Aggregate Exposed and Eroding
MH 02	9.1	Yes	Corroded (Pitted)	Corroded (Pitted/Worn)	Appears Defective	Appears Defective	Appears Defective	Material & Paper Deposits Extend to Castings. Two (2) Infiltration Gushers at Pipes
MH 03	13.7	Yes	Corroded (Pitted)	Corroded (Pitted/Worn)	Appears Defective	Appears Defective	Appears Defective	Material & Paper Deposits Extend to Castings. Minor Infiltration Stains at Pipes
MH 04	7.65	Yes	Sound	Corroded (Pitted/Worn)	Defective	Defective	Defective	Material & Paper Deposits Extend to Castings

- Although Manholes 01 and 13 showed evidence of surcharging, the condition of the manhole components were clearly defective. These manholes are generally in poor condition; Concrete spalling and exposure of aggregate necessitates the need for manhole rehabilitation or replacement.

**MH 13 Top View**

- Due to hydrogen sulfide gasses because of the drop, there is severe corrosion within the manhole and castings. There is deep pitting and spalling of concrete that has eroded the manhole walls to coarse aggregate. There are infiltration gushers at the wall joints as well. A full replacement of the manhole is recommended due to the accelerated deterioration.

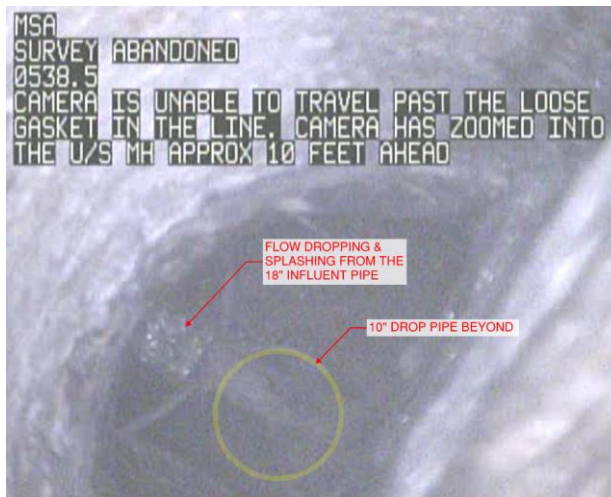
**CCTV Footage Looking Upstream Into MH 13**

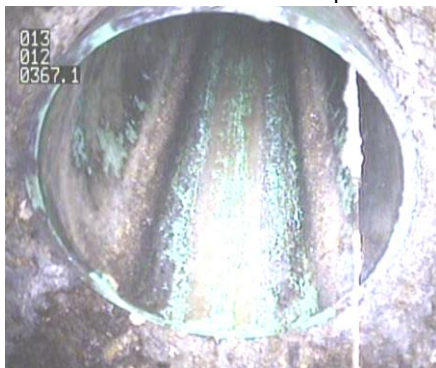
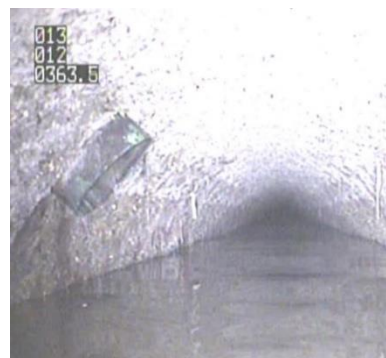
- Per record plans, a 6-inch service line for 2655 Wyndbend Blvd is tied into the sewer approximately 187-feet downstream of MH 13 or 350 feet upstream of Manhole 12 and is a protruding tap.

**6-Inch PVC Service Line for 2655 Wyndbend**

- Approximately 537 linear feet of 27-inch cured-in-place pipe (CIPP) sewer lining. Due to the existence of a 60-inch steel casing pipe and annulus grouting, it is recommended that a partial deteriorated pipe design be assumed for CIPP liner thickness calculations. Assume a 15 MM liner.
- Trim Protruding Tap – 6-Inch PVC service line for 2655 Wyndbend Blvd is protruding into the sewer and should be trimmed flush with the 27-inch sewer prior to lining.

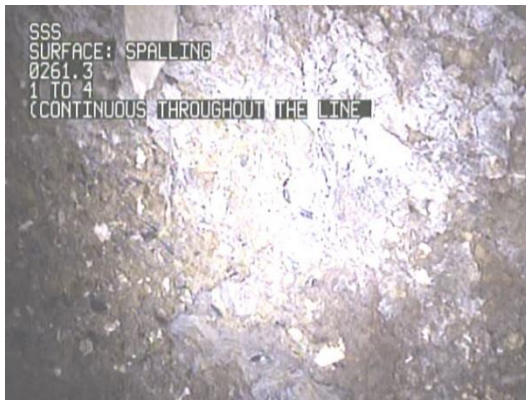
- At the time of the CCTV video recording (4/10/23), it does not appear any pre-cleaning occurred due to the presence of rags and encrustations
- Fine and coarse aggregates are exposed for the entire pipe run

**Fine & Course Aggregate Exposed**

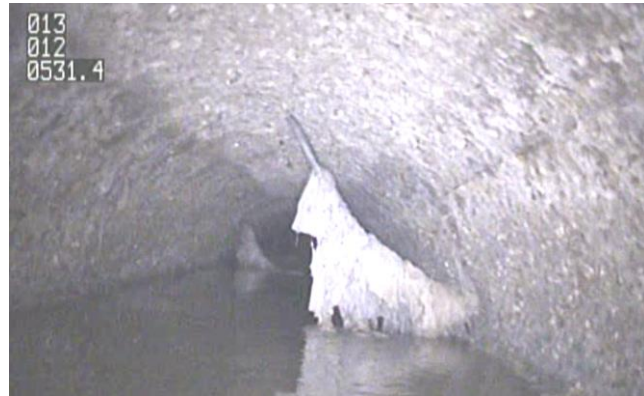
- Several defective gaskets (dropped) are present near the upstream end of the pipe segment near MH 13. This is likely due to more corrosive gases near the drop manhole (MH 13). These defective gaskets at the joints are causing a large amount of deposits and rags to accumulate and impact the flow.

**Defective Gaskets**

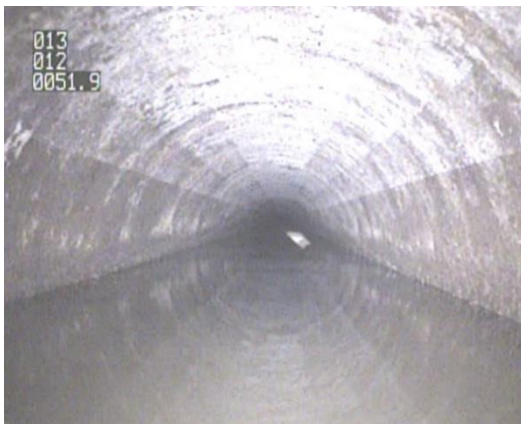
- Reinforcement is exposed and/or has minimal concrete cover for the entire pipe run. In some sections, the rebar is partially exposed. The severity of exposure increases the closer to MH 13

**Reinforcing Bars with Minimal Concrete Cover**

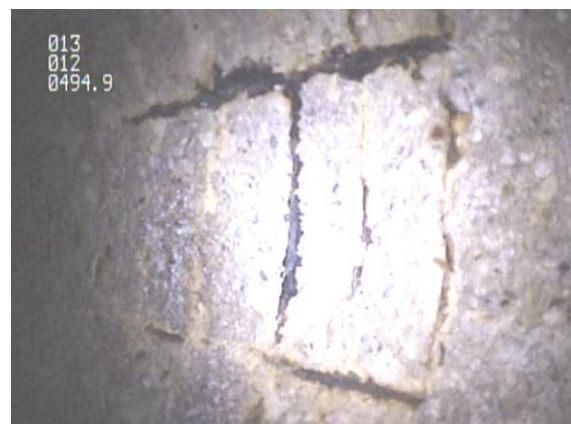
**Exposed Rebar Cages**
