# REQUEST FOR TECHNICAL PROPOSALS

## Northstar Ductile Iron Sewer Main Assessment & Design Project

### ATTACHMENT A - PROJECT LOCATION AND SUMMARY

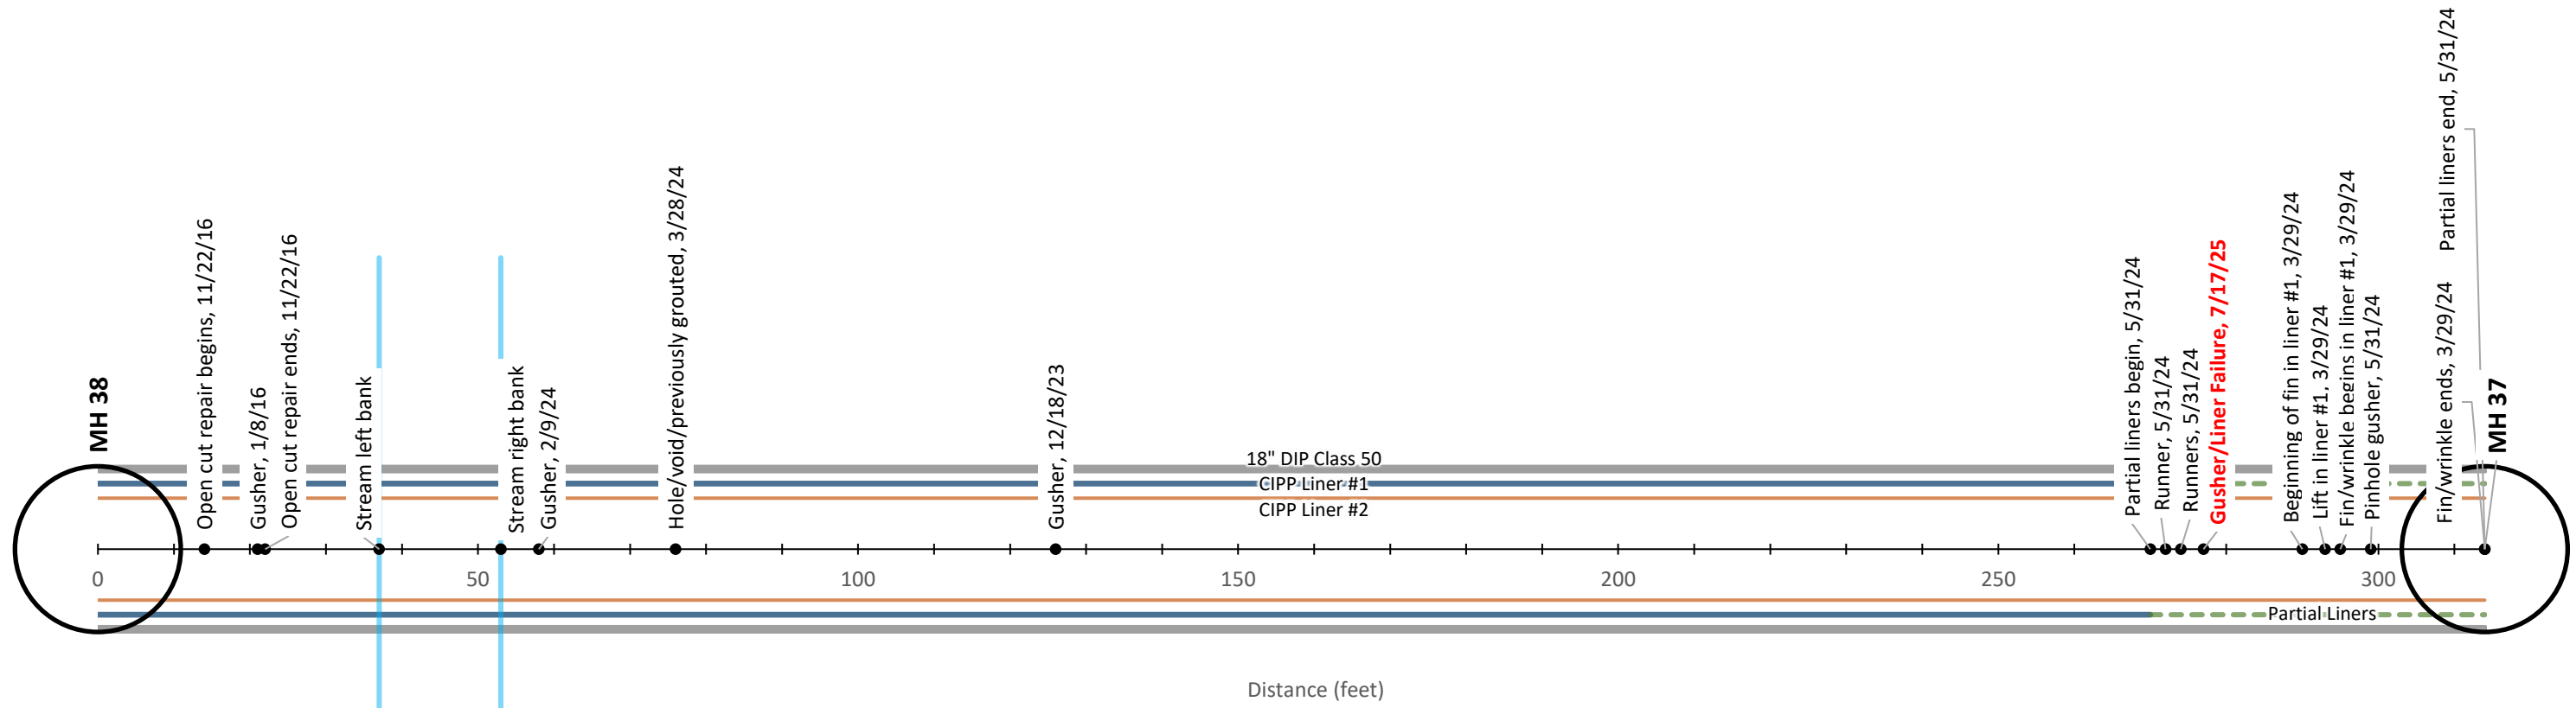
FIGURE 2

- DIP located between MH 37 and MH 38 (2016, 2023 – 2025) /Segment 1 (**Figure 2** is a schematic of the history of defects and rehabilitation efforts on this segment).
- DIP located between MH 38 and MH 39 (2025)/ Segment 1
- DIP located between MH 35 and MH 36 (2023)/ Segment 2
- DIP located between MH 39 and MH 40 (2026)/ Segment 3

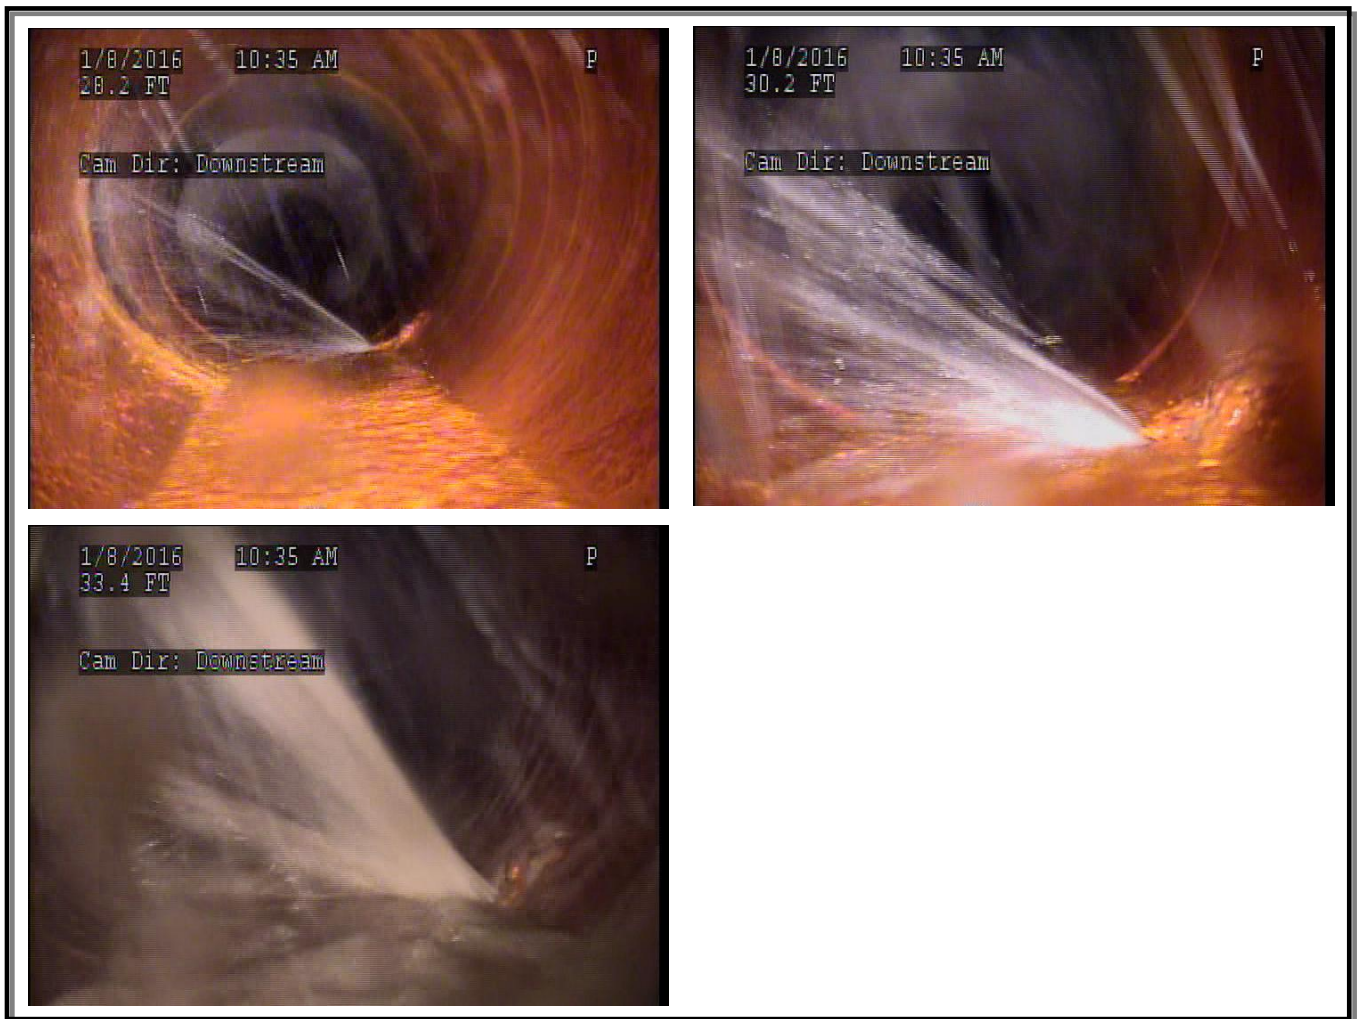
DCRSD has observed recurring failures with DIP located between MH 37 and MH 38. In 2016, a severe groundwater leak, known as a "gusher," was found in the pipe near Station 21 (see **Figure 2**) and downstream of MH 38. An open-cut repair was performed on this pipe segment. Photos of the gusher are shown in **Figure 3**, and construction photos in **Figure 4**.

**Figure 3: 2016 Gusher (MH 37 – MH 38)**

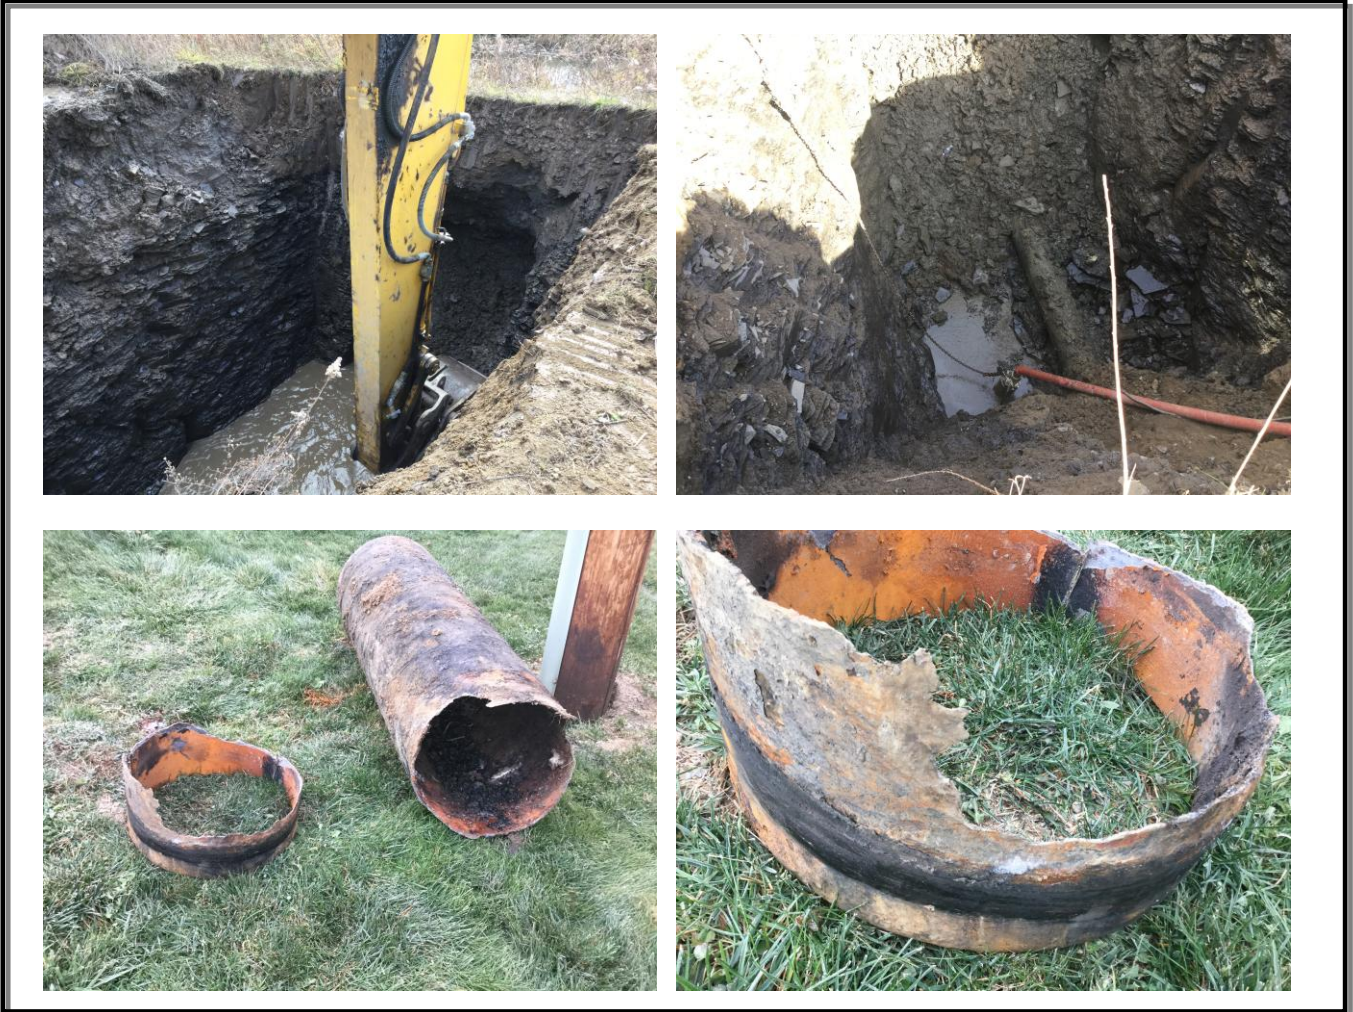
Figure 4: 2016 Construction (MH 37 – MH 38)

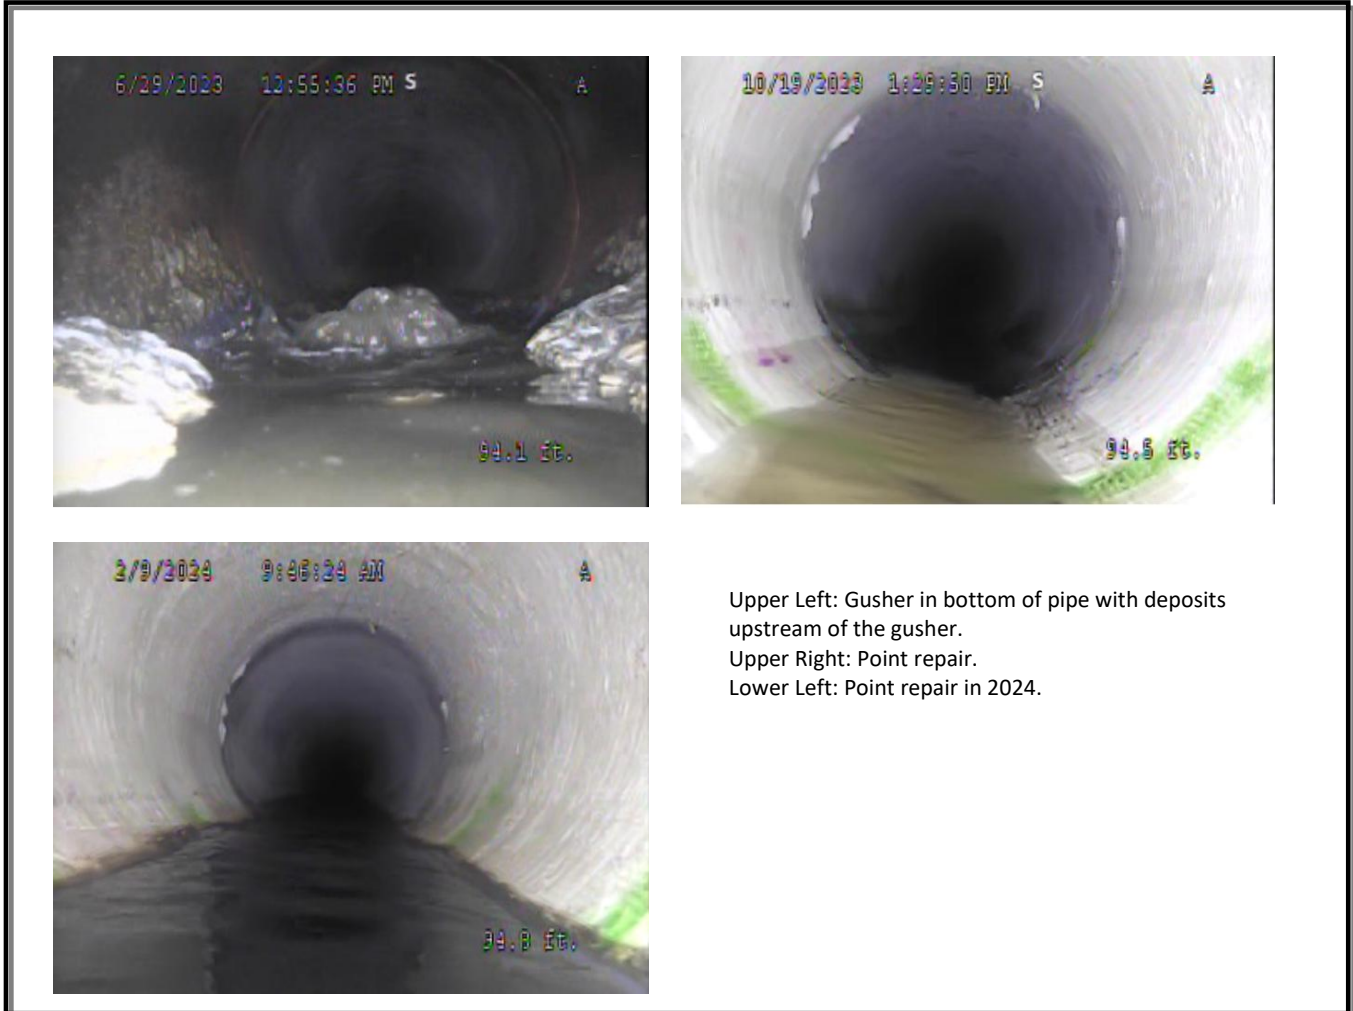
In July 2023, DCRSD observed defects in the DIP segment located between MH 35 and MH 36. At the time, DCRSD assumed this to have been a utility strike, but with the compounding issues on the other DIP sewer pipes, it is unclear if that assumption was accurate or not. Visu-Sewer performed a point repair in this pipe segment in October 2023.

Figure 5: 2023 gusher (MH 35 - MH 36) and point repair

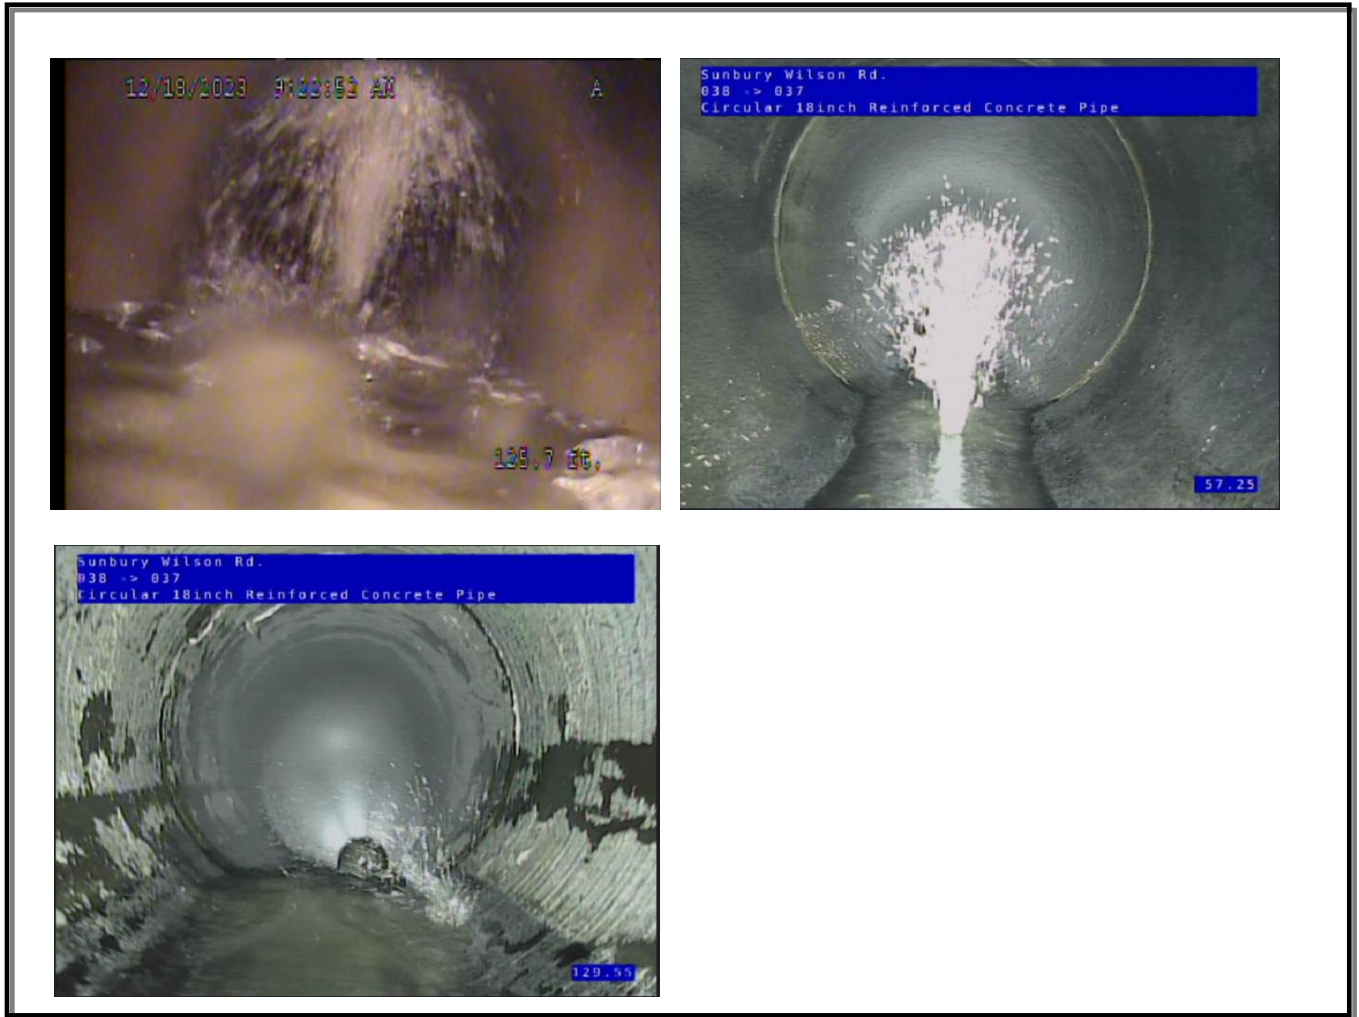
On December 18, 2023, the DCRSD's CCTV inspection showed a new gusher in DIP segment located between MH 37 and MH 38 near Station 126 (see **Figure 2**) and downstream of manhole 038. DCRSD hired Visu-Sewer to perform a point repair on this segment of the 18-inch DIP sewer. In early January 2024, Visu-Sewer's subcontractor attempted the point repair, but failed, and returned to remove the failed partial liner as part of their pre-cleaning activities. Due to scheduling delays with the subcontractor, Visu-Sewer chose to return to the site in early February to grout the pipe segment and reduce the infiltration until the point repair could be completed. Without any additional timeline able to be provided by Visu-Sewer for the point repair to be completed, DCRSD terminated the contract and proceeded to move on to a new contractor. There was no CCTV provided by Visu-Sewer during this time period for the work completed.

DCRSD staff completed CCTV inspection on February 9, 2024, on this sewer segment after the grouting was completed by Visu-Sewer and before hiring a new contractor. At this time, a second new gusher was identified near Station 58 (see **Figure 2**) and downstream of MH 38. Therefore, DCRSD decided to have a full-length cured-in-place pipe (CIPP) lining installed between MH 37 and MH 38 and hired United Survey Inc. (USI) to design and perform the work. As well, DCRSD utilized DLZ Corporation to provide on-site construction inspection and oversight of the project during installation. The CIPP liner #1 was completed in March 2024. Review of the post installation video showed the jetter head moving around something around 282 feet and a potential lift in the liner from Station 285 to 289 feet that turns into a fin at Station 290 feet and continues with issues until the end of the CIPP liner section. USI decided that from approximately Station 270 feet to the end of the pipe segment (MH 37), a partial overtopping CIPP liner would be installed to address the issue. This work was completed in May 2024, and pinhole leaks were observed in the overlapping liners, so USI returned in July 2024 and installed a completely new CIPP liner #2 over the initial liner and partial liners. Pictures of the gusher are shown in **Figure 6**, and some of the rehabilitation work in **Figure 7**.

Figure 6: 2023/2024 gushers (MH 37 – MH 38)

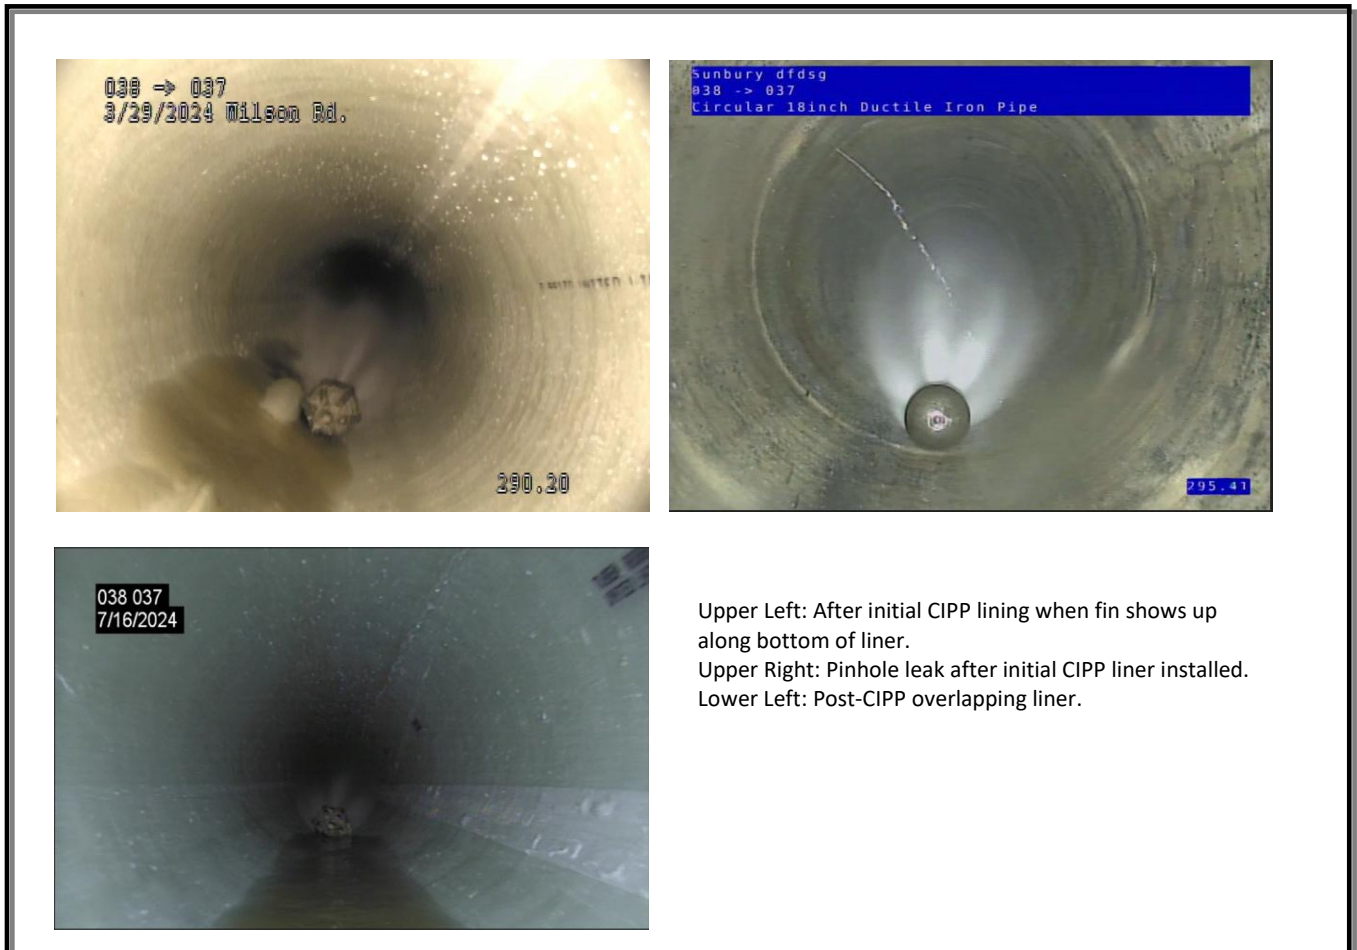
Upper Left: After initial CIPP lining when fin shows up along bottom of liner.  
Upper Right: Pinhole leak after initial CIPP liner installed.  
Lower Left: Post-CIPP overlapping liner.

**Figure 7: 2024 CIPP Lining (manhole 37 - 38)**

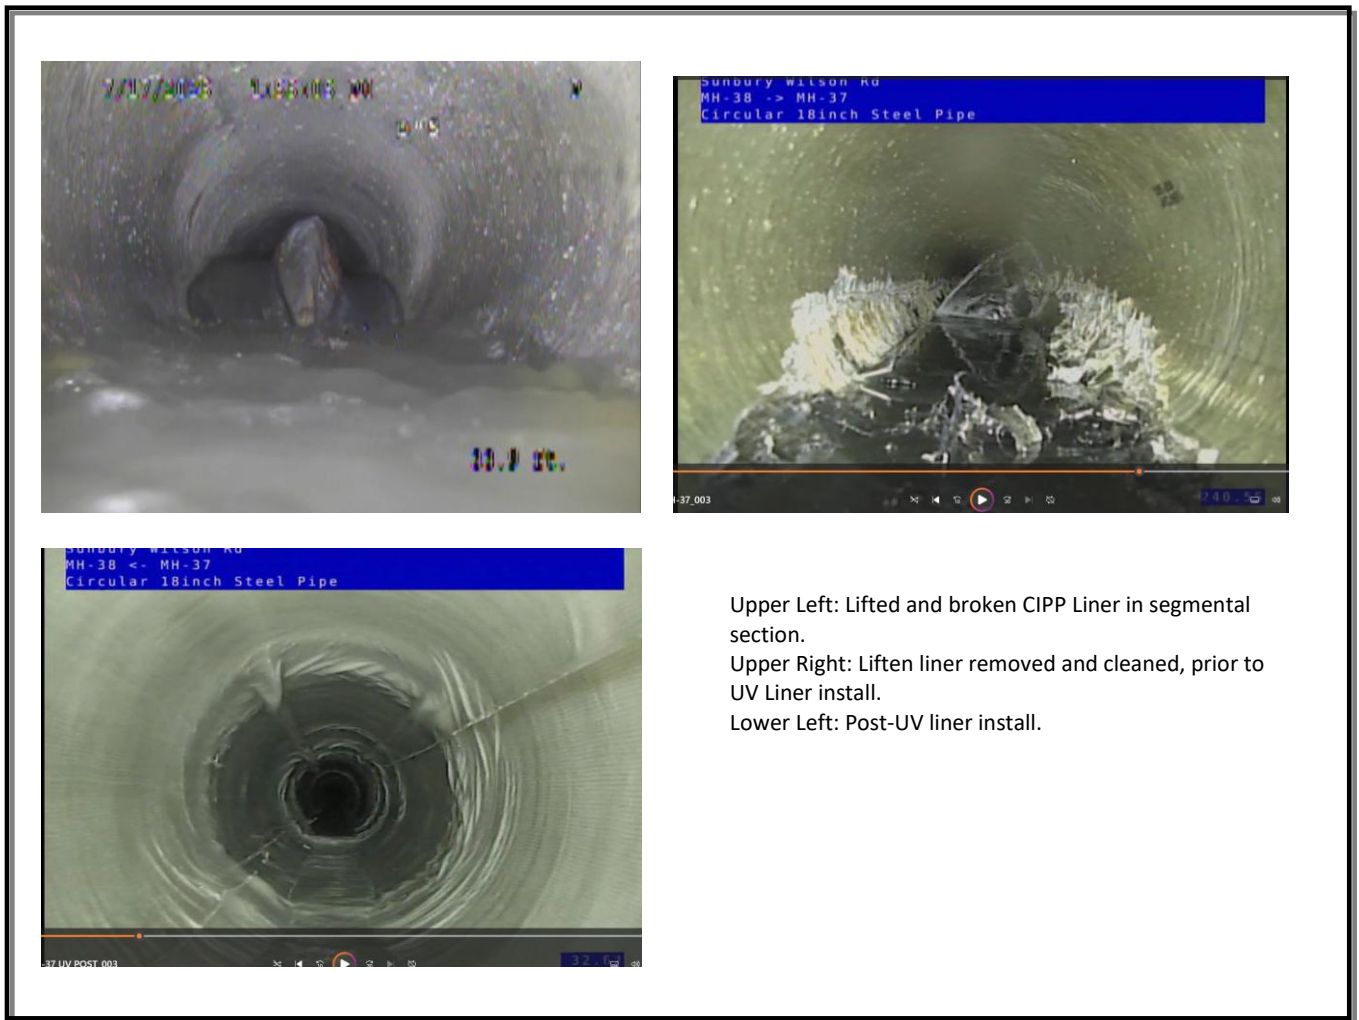
One year later, DCRSD noticed a significant increase in the Northstar WRF plant flows in July 2025 and performed CCTV inspection of this sewer segment going upstream from MH 37 to MH 38 and found that the previously installed partial overtopping liners had been lifted upward, the bottom liner appears to have pushed through the top liner, and was causing approximately a 75-80% pipe blockage.

In early August 2025, USI mobilized to the site to assess site conditions and remove approximately 40 feet of the lifted liner to restore full-flow capacity in the pipe. At that time, they confirmed no additional liner defects in the CIPP liner. They also identified a new gusher in DIP located between MH 38 and MH 39, approximately 125 feet upstream from MH 38. By mid-August, the USI team proposed using partial liners again as a repair method, which raised concerns among DCRSD staff. Through collaborative discussion, the USI team, DCRSD staff, and representatives from DLZ had agreed in mid-September to move forward with the installation of UV-cured CIPP liner for both pipe segments currently observing the groundwater gushers between MH 37 and MH 39. Photos of the uplifted liner are shown in **Figure 8** along with some of the rehabilitation work.

Figure 8: 2025/2026 Lifted liner and UV liner Rehabilitation (manhole 37 - 38)

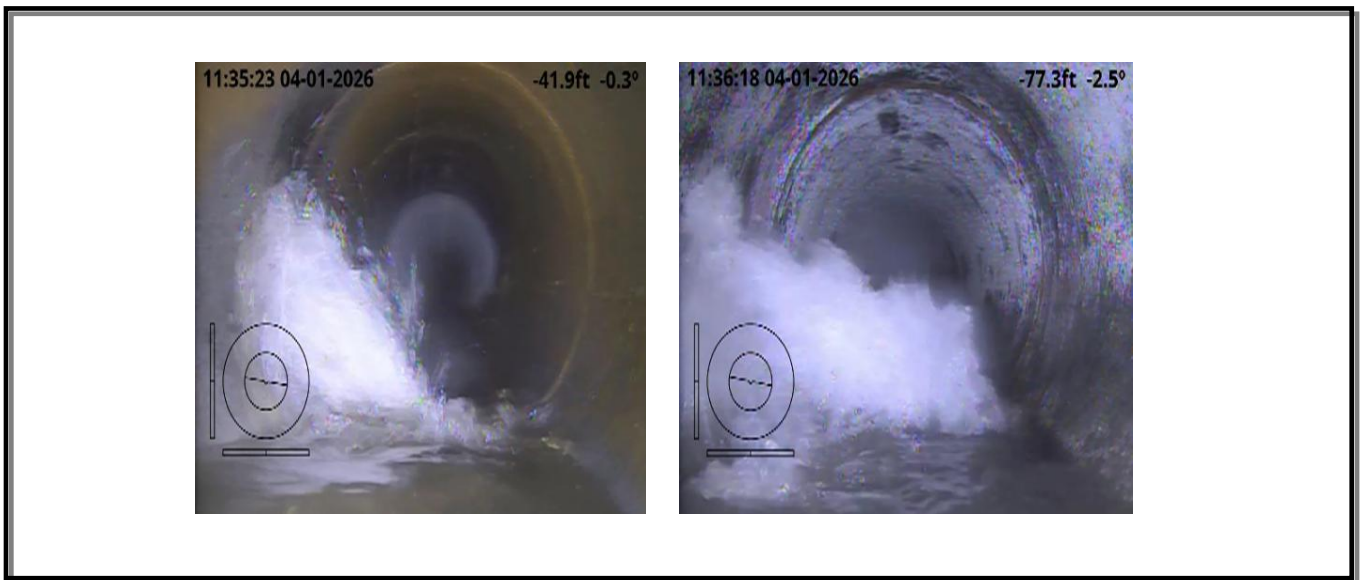
In March 2026, the Northstar WRF observed increased flows at the plant, so the DCRSD's staff performed a CCTV inspection of the DIP sewer pipe and found two gushers in DIP located between MH 39 and MH 40, and directly upstream of the two pipe segments that just received the UV-Cured CIPP lining. The CCTV video observed one gusher approximately 40 ft upstream of MH 39. As the CCTV inspection crew was retracting the camera out of the pipe segment, they observed a new gusher that formed mid-inspection, 77 feet upstream from MH 39. Photos of the gushers are shown in **Figure 9**.

**Figure 9: 2026 gusher (manhole 39 - 40)**
