**FINAL REPORT  
OF  
PHASE 1 – PRELIMINARY ENGINEERING SERVICES**  
*Golf Village Force Main Outfall and Downstream Sewer Improvements*

*PO No. P2502198*

*Liberty Township, Delaware County, Ohio*

June 30, 2025

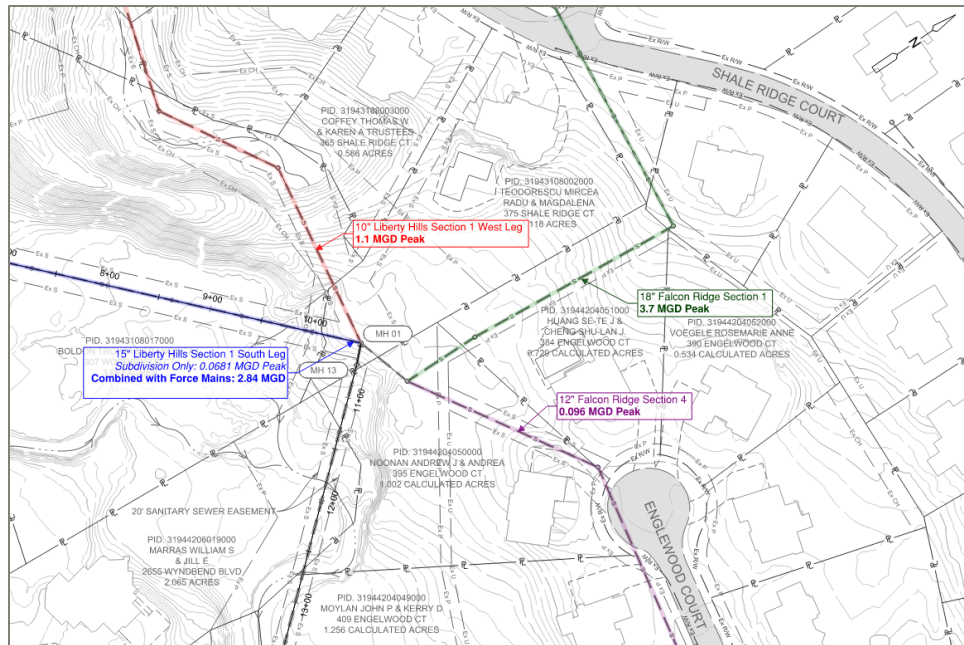
**Table 3 - Average and Peak Flows for Tributary Sewers and Force Mains at MH 01**

Sewer Segment	Flows (MGD)	
	Average	Peak
14" Golf Village Force Main	-	2.05 MGD
8" Lakes of Powell Force Main	-	0.72 MGD
15" Liberty Hills Section 1 South Leg	0.0086 MGD	0.0681 MGD
10" Liberty Hills Section 1 West Leg	0.30 MGD	1.1 MGD
18" Falcon Ridge Section 1	0.75 MGD	3.7 MGD
12" Falcon Ridge Section 4	0.0084 MGD	0.096 MGD
<b>Total Required at MH 01:</b>		<b>8 MGD</b>

**Figure 1 - Peak Flows Tributary to Manhole 1**

To bypass sewer flows discharging into the Jewett Road Trunk Sewer and to replace Manhole 13, it is recommended that the junction manhole (Manhole 01 - Asset ID 09MH001353000001) be used for the primary location for a singular bypass system. The operating conditions of the bypass system will need to be checked during detailed design to ensure any surcharging within the manhole does not induce any water-in-basements (WIBs).
